Asbestos and Lead-Based Paint Survey Report

1510 Truxtun Ave.
Old Barracks M17
North Charleston, South Carolina

February 5, 2020
Terracon Project No. EN197470

Re: Asbestos and Lead-Based Paint Survey Report
Old Barracks M17
North Charleston, South Carolina
Terracon Project No. EN197470

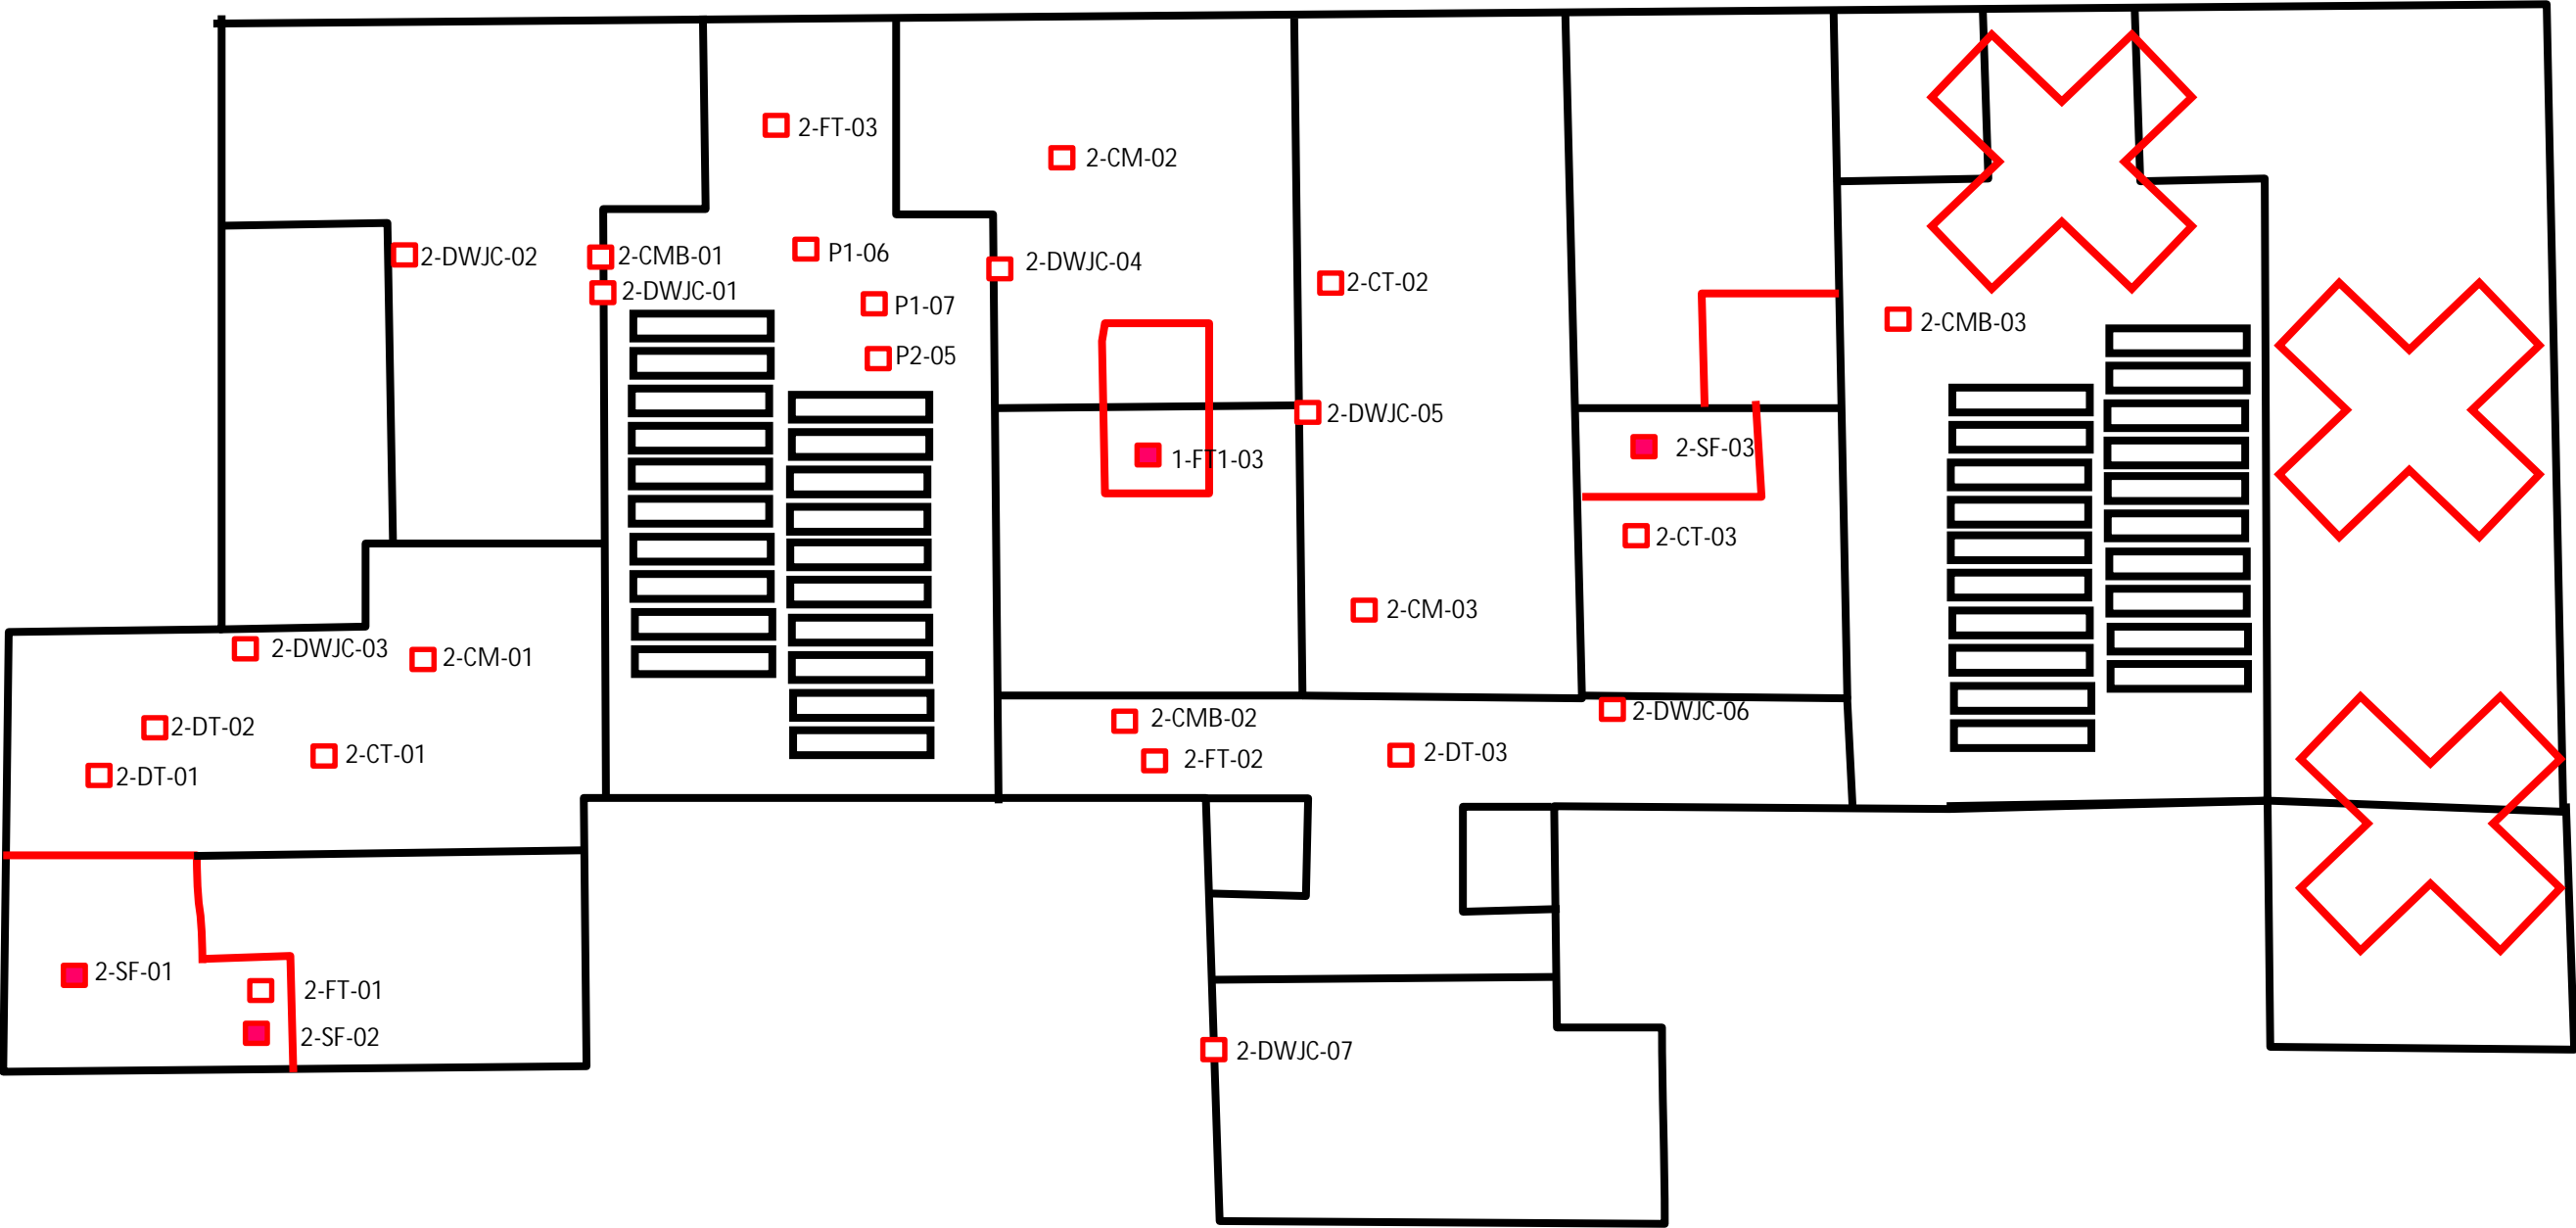
2nd Floor

- Non-friable sheet flooring (10 % Chrysotile) associated with the bathrooms flooring located on the second floor. No mastic was observed in the laboratory analysis. If mastic is observed onsite, it should be assumed to contain asbestos.

Terracon recommends removal of the asbestos-containing materials by a South Carolina licensed asbestos abatement contractor prior disturbance of these materials during renovation of the building. Additionally, third-party air monitoring is required during abatement since the aforementioned non-friable materials are damaged.
